ROAD SAFETY AUDIT

SEDGWICK ROAD: SOUTH MAIN STREET TO RIDGEWOOD ROAD

March 2025

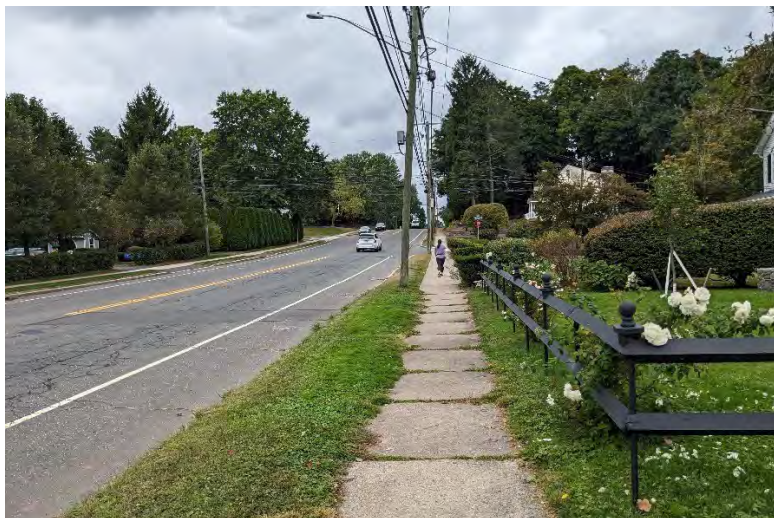
Exhibit 4: Vegetation Encroachment on Sidewalk

- Road surface and sidewalk surface conditions vary, with areas of poor surface conditions. Sidewalks throughout the study area are constructed with concrete. Heaving is prevalent, particularly at driveways. Vegetation encroachment is also notable in locations.

- Pedestrian accommodation and crossings.
- Lack of bicycle accommodations.
- Poor roadway and sidewalk surface condition, as displayed in Exhibit 4. Roadway conditions are expected to improve in 2025 with a planned reconstruction of the corridor between South Main Street and Wardwell Road.

- Repair sidewalk slabs in need of repair.
- Replace all streetlight fixtures to ensure all lighting meets lumen output recommended by AAHSTO *Roadway Lighting Design Guide* (2018). To meet an average 0.7 foot-candle illuminance, as recommended for a minor arterial in a residential area, 6,000 lumen minimum, Type III fixtures should be considered. 8,000 lumen, Type III fixtures *could* be considered adjacent to the middle school to provide increased lighting levels in this area. Existing fixtures are 4,000 lumen.

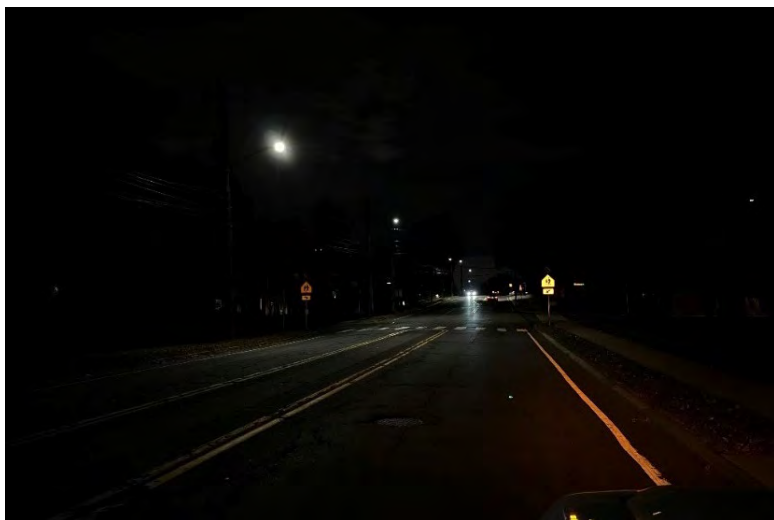
Exhibit 5: Sedgwick Road Night Visibility (view east toward Lemay Street crosswalk)

- Overhead street lighting. While the RSA was conducted during daylight hours, Town staff conducted a night-time field visit to evaluate lighting levels and conducted a desktop review of lighting. A photo of nighttime conditions is presented in Exhibit 5. Based on this review, the Town is planning additional or modified overhead streetlight fixtures at the following locations:

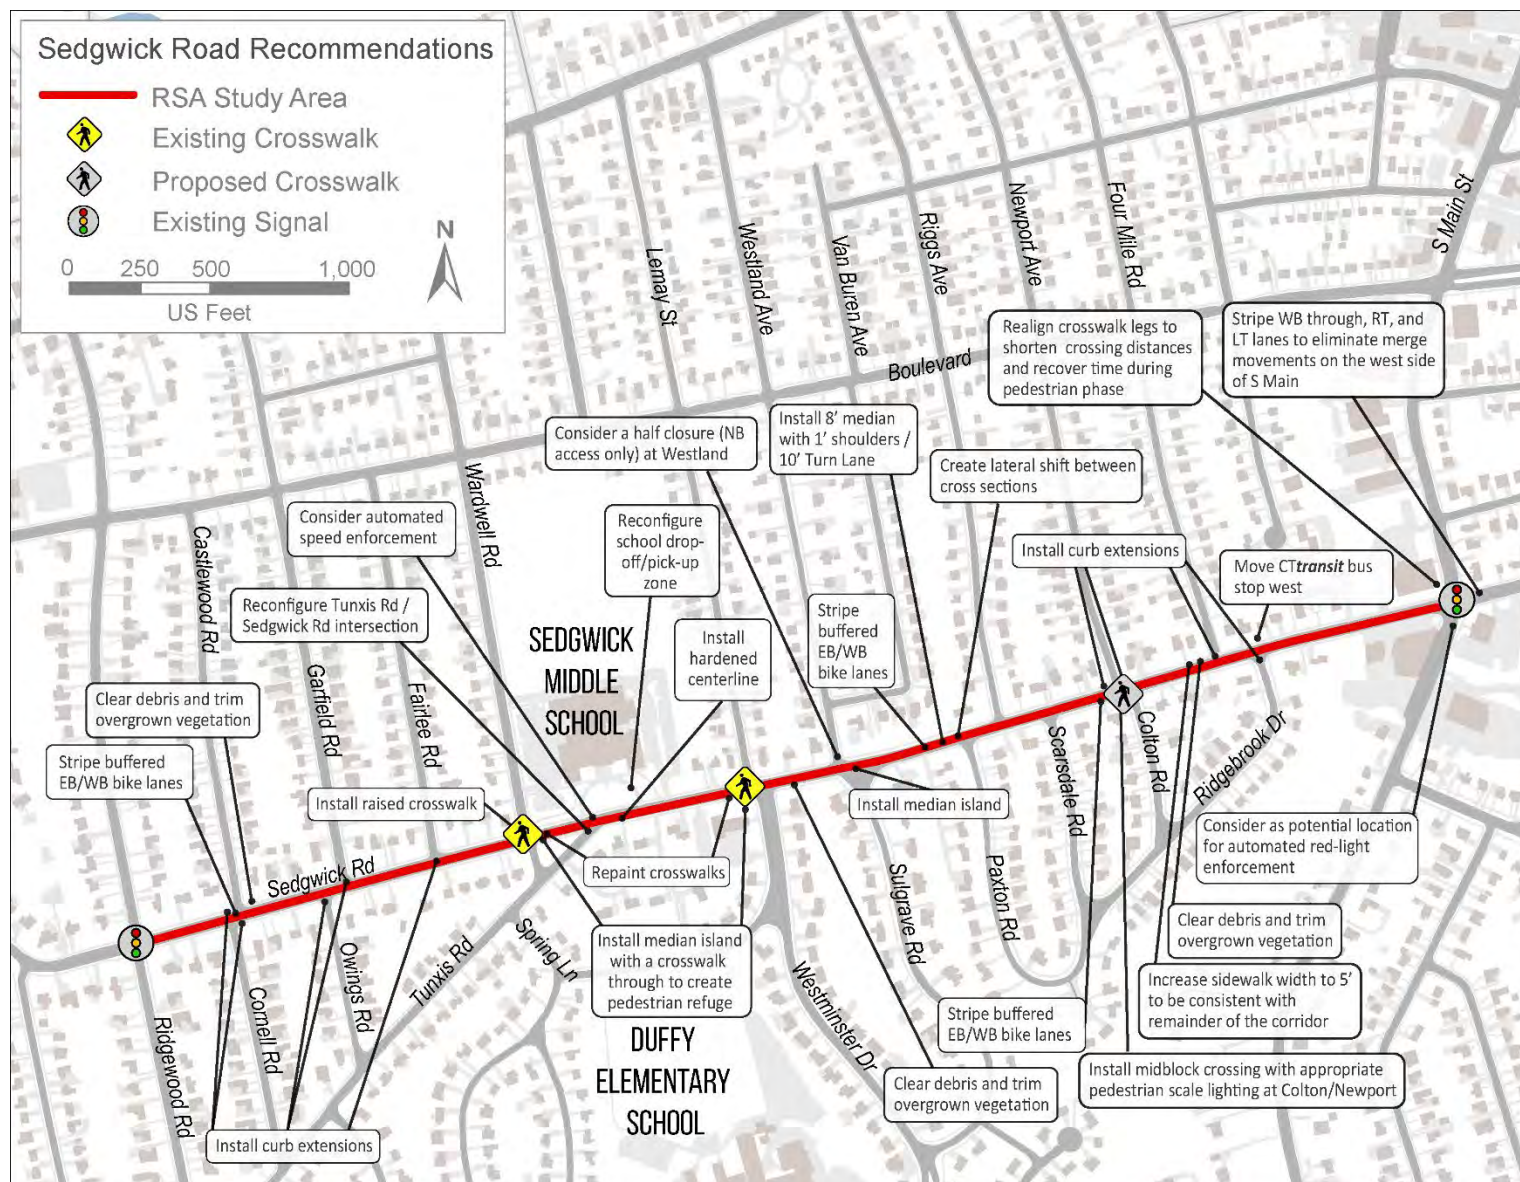
Exhibit 6: Corridor Recommendations

Details on site-specific findings and recommendations are summarized in the subsequent sections. Exhibit 6 provides a summary map of corridor recommendations. Exhibit 7 and Exhibit 8 show cross sections at various locations on Sedgwick Road.

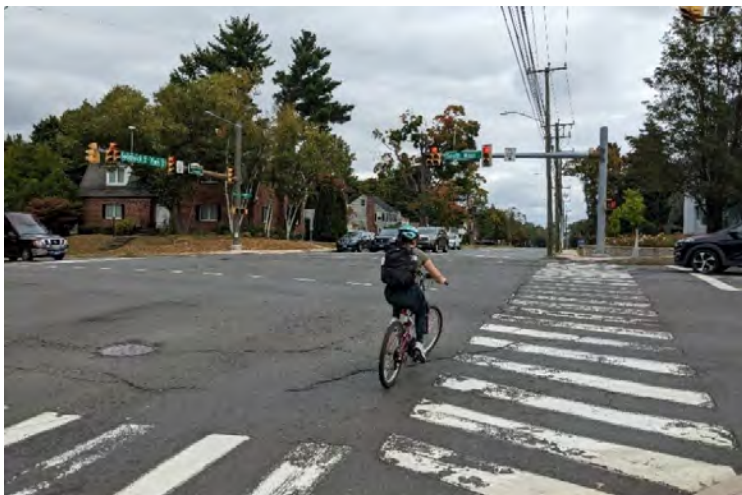
Exhibit 9: Sedgwick Road / South Main Street Intersection Crosswalks

- The crosswalk paint at the intersection is in fair to poor condition and needs maintenance. Exhibit 9 displays crosswalks at the intersection.
- This location is a crossing guard post during school days.

- Realign the crosswalk legs to shorten crossing distances to improve pedestrian safety. Maintain exclusive pedestrian phase with this modification.
- Install NTOR blank out signs, as displayed in Exhibit 11.

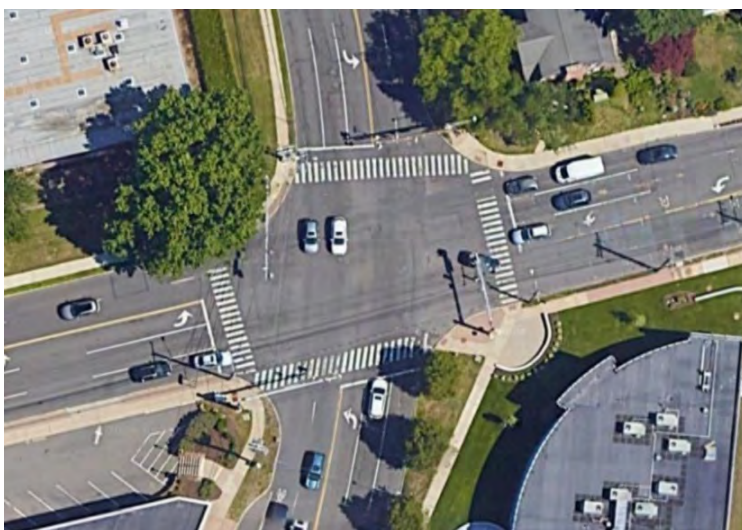
Exhibit 10: Existing Lane Configuration at Sedgwick Road / South Main Street Intersection (Source: Google Maps)

Exhibit 10 displays the lane configuration and crosswalk locations.

- All four approaches are signed for NTOR. Police stated that many drivers do not obey the NTOR signage at both the eastbound and westbound approaches to the intersection

- Review signal timings to ensure adequate green time provided for all movements, especially left-turn movements.
- Restripe and reconfigure the westbound approach to South Main Street. Convert the curbside lane (currently a shared through / right lane) to a dedicated right-turn lane. This would eliminate the need to carry two westbound lanes on Sedgwick Road west of South Main Street and eliminate the need for a merge at this location. This recommendation aims to streamline traffic flow, reduce conflicts, and enhance safety by eliminating merge movements and clarifying vehicle paths. Further review reconfiguration options for eastbound approach to verify infeasibility of lane reconfiguration as was reported in Synchro traffic analysis software. This effort will require coordination with OSTA.

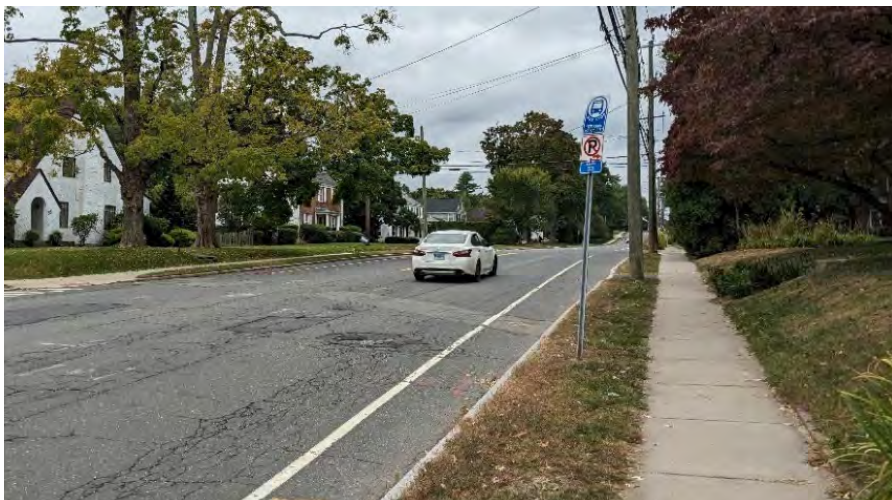
Exhibit 13: CTtransit Stop near 24 Sedgwick Road at Westbound Lane Merge

- Participants stated that the painted medians with rumble strips are not as effective for traffic calming as desired. Exhibit 13 through Exhibit 18 display existing conditions through this area of the corridor.

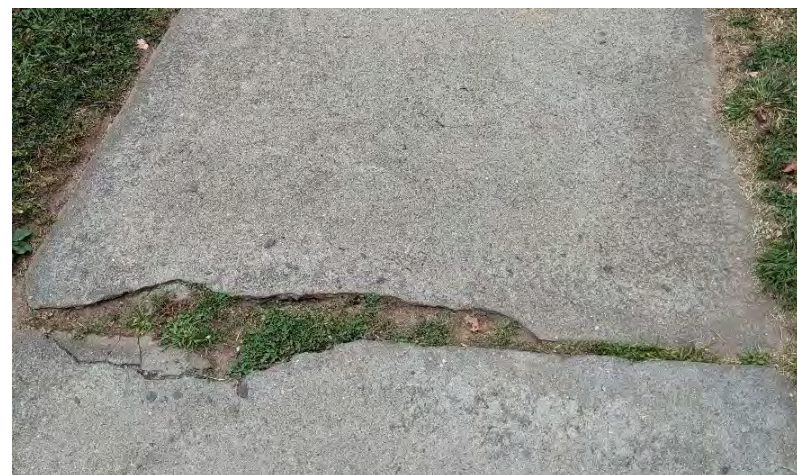
Exhibit 15: Sidewalk with Cracked Pavement and Vegetation

- Sidewalks are generally in fair condition. Some sections show signs of heaving.
- There are few street trees in this area.
- There are no midblock crossings in this area.

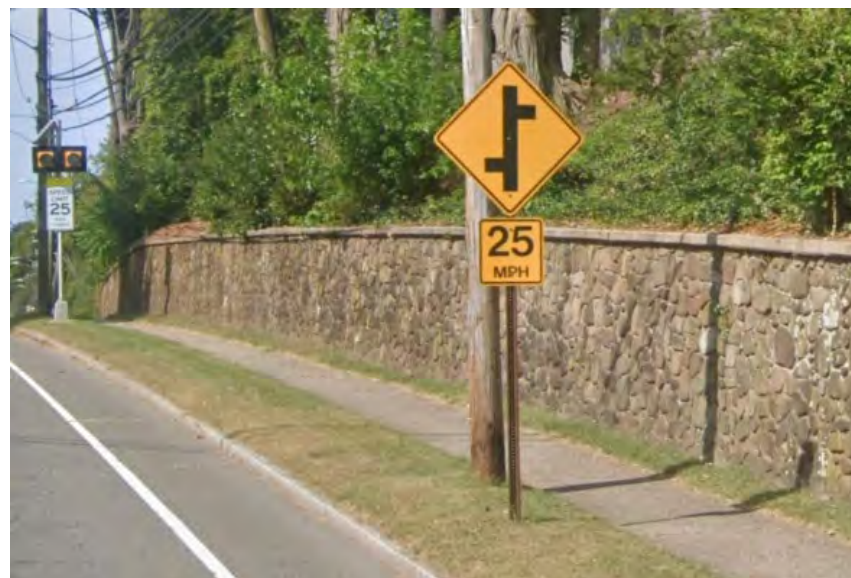
**Exhibit 18: Westbound 25 MPH Advisory Speed for
Sedgwick Road at Sulgrave Road / Westland Avenue**

- Participants noted that the westbound left-turn lane to Westminster Drive is helpful for westbound traffic as stopping sight distance is limited in this area and left-turning traffic can be queued up to Sulgrave Road. The vertical curve presents a stopping sight distance of approximately 230 feet based on a desktop review of the curve. This correlates to a design speed of 30 MPH based on Figure 7-1A in the CTDOT Design Manual. Appendix D presents vertical sightlines on Sedgwick Road.

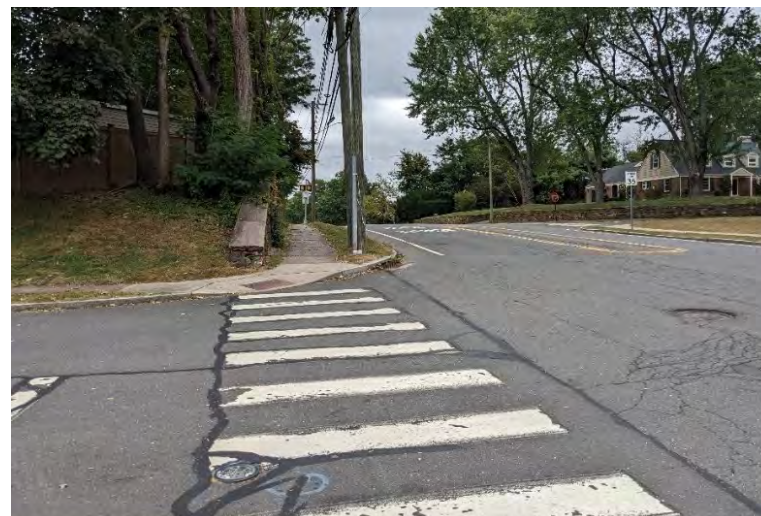
**Exhibit 20: View East from Westland Avenue towards
Vertical Hill on Sedgwick Road**

- Exiting onto Sedgwick Road from Westland Avenue was observed to be challenging for drivers because of the steep grade on Sedgwick Road to the east, as displayed in Exhibit 20 which creates potential sightline issues. Drivers on Westland Avenue have limited sightlines when traveling westbound up over the hill on Sedgwick Road. The vertical crest curve presents an intersection sight distance of 280 feet for passenger vehicles and 360 feet for single unit trucks based on desktop review of the curve, as presented in Appendix D. This correlates to a design speed of 25 MPH based on Figure 11-2C in the CTDOT Design Manual. Exhibit 21 displays signage at the Westland Avenue stop sign. Exhibit 22 displays the flashing school sign westbound on Sedgwick Road.

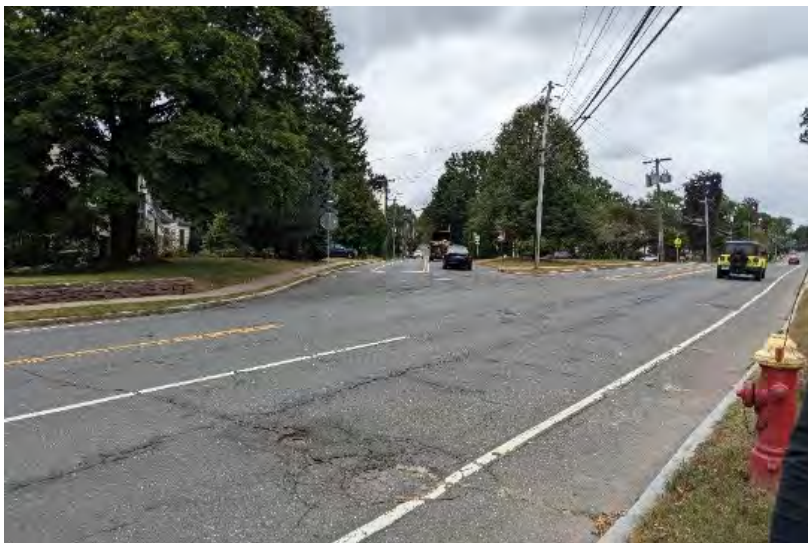
Exhibit 24: View Toward Tunxis Road

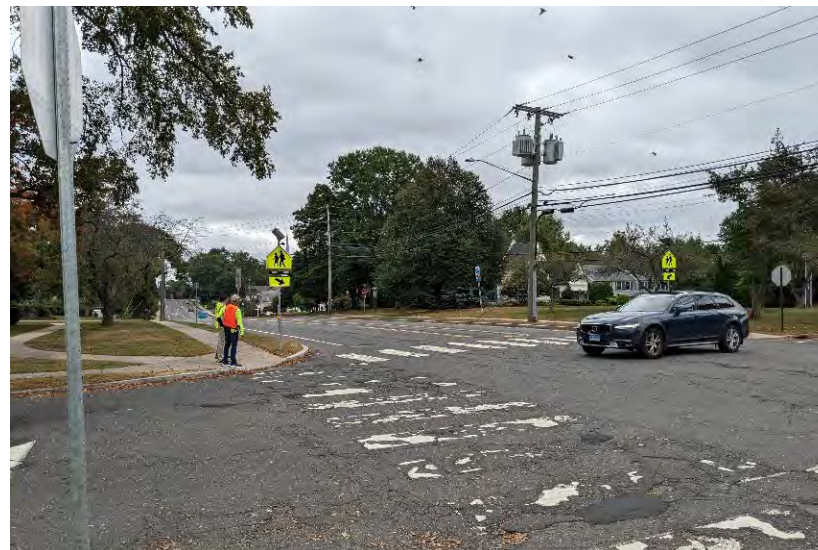
Exhibit 25: Crosswalk at Wardwell Road in Poor Condition

- School representatives noted that students typically utilize the crosswalks and sidewalks in the area.
- Crosswalks are in poor condition in this area, as shown in Exhibit 25 and Exhibit 26. There is an RRFB at the crosswalk on the east side of Wardwell Road intersection, as shown in Exhibit 26. However, pedestrians typically cross this intersection from the southwest corner even though there is no RRFB located at this corner.

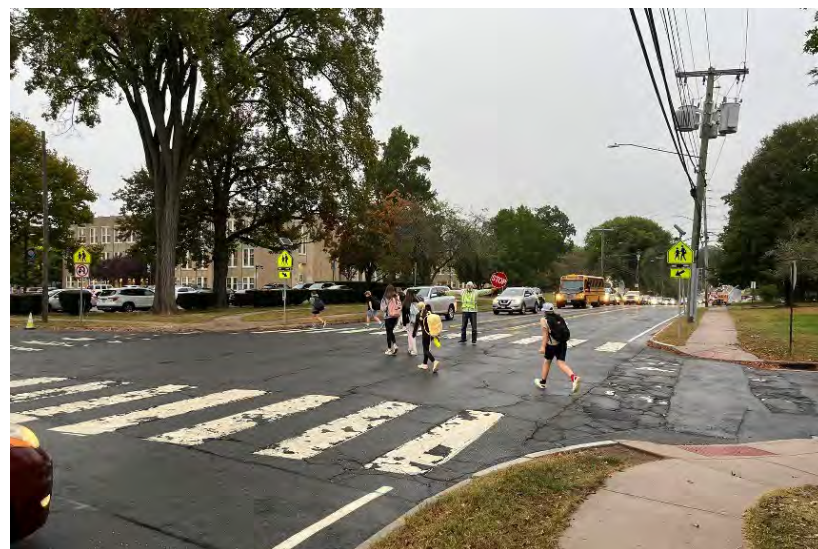
Exhibit 26: Wardwell Road Crosswalk at Morning Arrival

- An eastbound left-turn lane to Wardwell Road was installed in 2019 to alleviate congestion concerns in the eastbound direction related to school drop-off. This has caused some concern at the crosswalk at Wardwell Road because of fast-moving eastbound traffic and limited sight lines to the crosswalk because of stopped vehicles turning left.

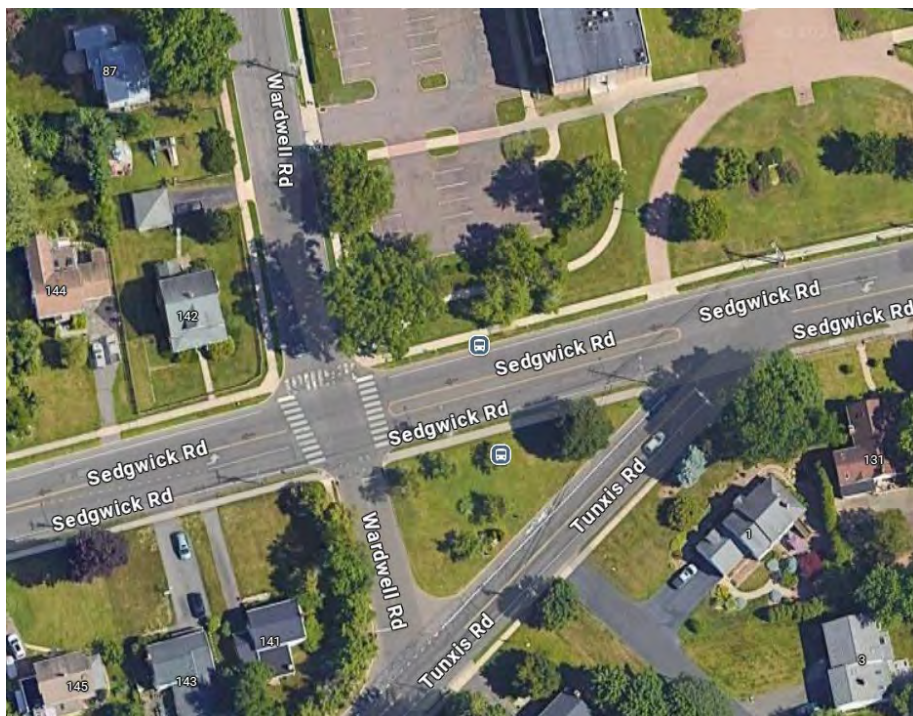
Exhibit 27: Sedgwick Road, Tunxis Road, and Wardwell Road Intersection

and impacts property on the southwest corner of the Sedgwick Middle School campus. A roundabout **should not** be considered until congestion concerns related to parent drop-off / pick-up for Sedgwick Middle School are addressed. Queuing through a roundabout would be detrimental to passage of all movements and a roundabout should generally not be considered in these circumstances

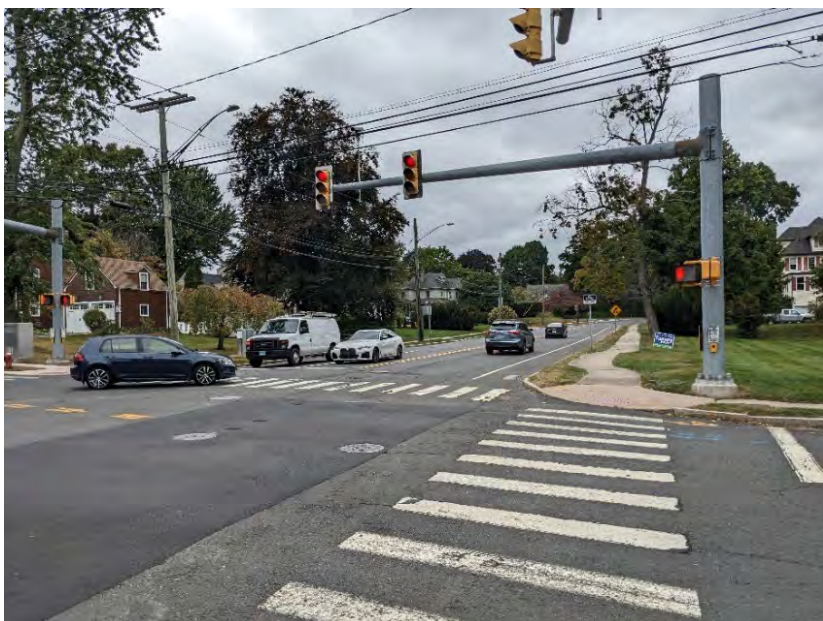
Exhibit 28: View of Sedgwick Road West of Ridgewood Road Intersection

- Stripe 5-foot eastbound/westbound bike lanes
- Stripe 10-foot eastbound/westbound travel lanes

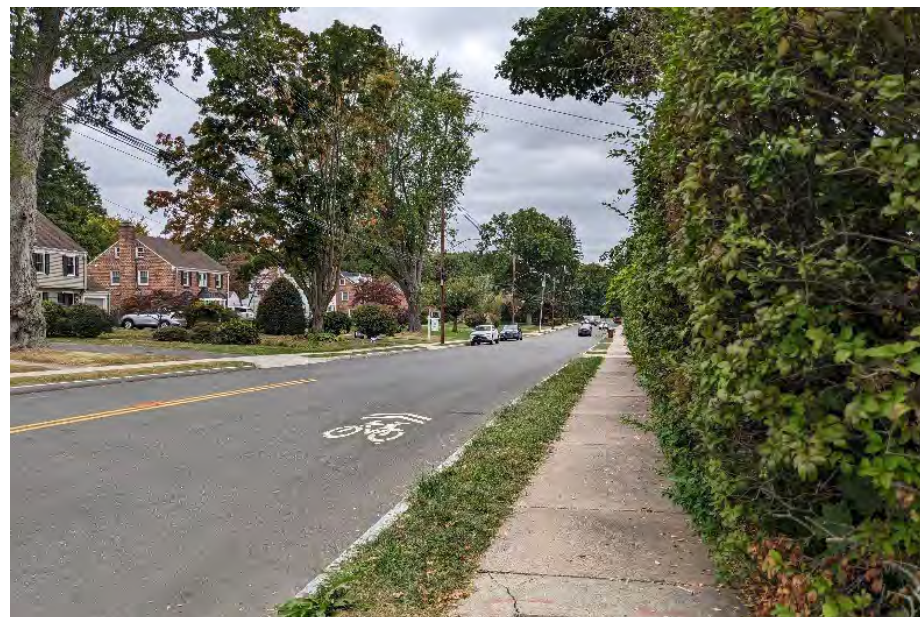
Exhibit 29: Overgrown Vegetation, View North of Sedgwick Road on Ridgewood Road

- Overgrown vegetation and sightline issues were observed at:
 - Garfield Road (northwest corner)

- Castlewood Road (northeast corner)
- Cornell Road (southeast corner)
- Owings Road (southeast corner)
- Fairlee Road (northwest corner)
